Introduction

Project aims

The aim of this project is to assess the distribution and use of iron-bound or ferruginous gravels and sands, Roman tiles and (Leziate) grey quartzite stone in Norfolk's early churches. The author has approached this as a field archaeologist rather than as an architectural historian and he hopes that this will add some new perspectives to a fascinating subject.

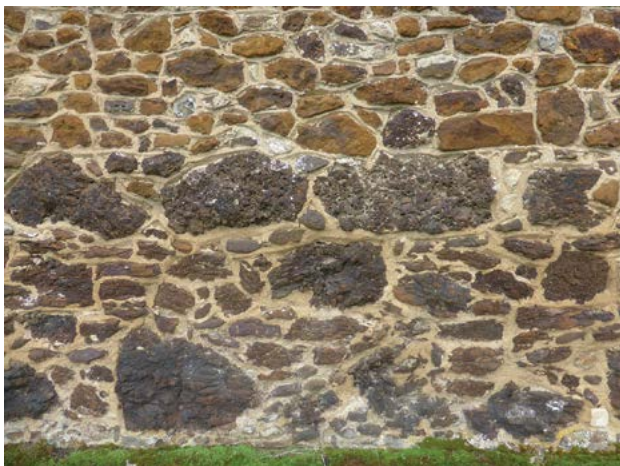
1.1. Bexwell close-up of the stonework in the east wall of the chancel wall which has a mixture of light brown Carstone and larger blocks of darker ferruginous conglomerate.

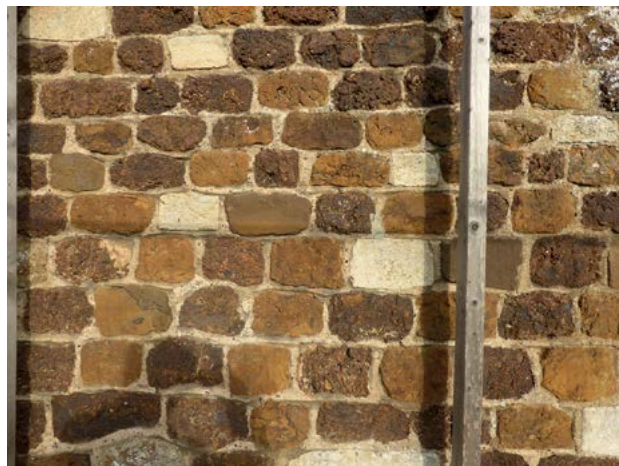
1.2. Wimbotsham south wall of the chancel which has a decorative mixture of light brown Carstone, darker brown ferruginous conglomerate and limestone.

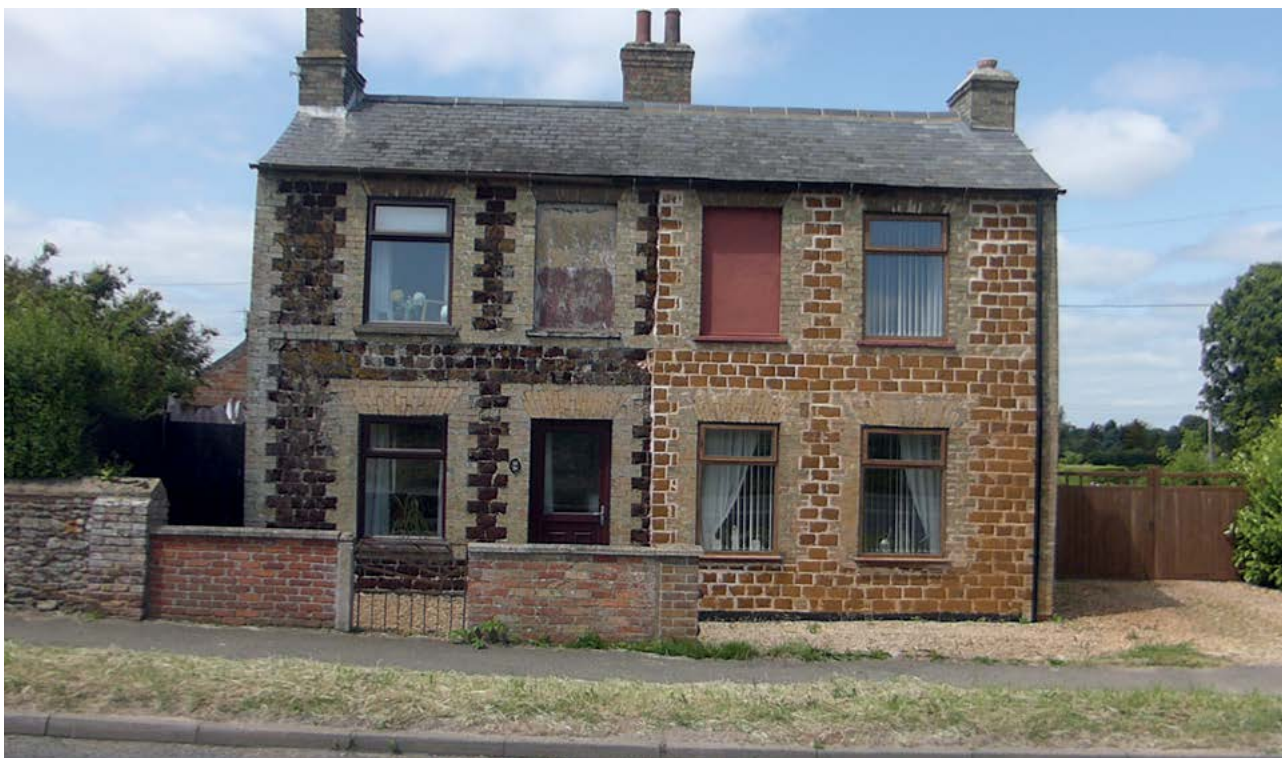
1.3. Wimbotsham pair of cottages with conglomerate to the left and Carstone to the right.

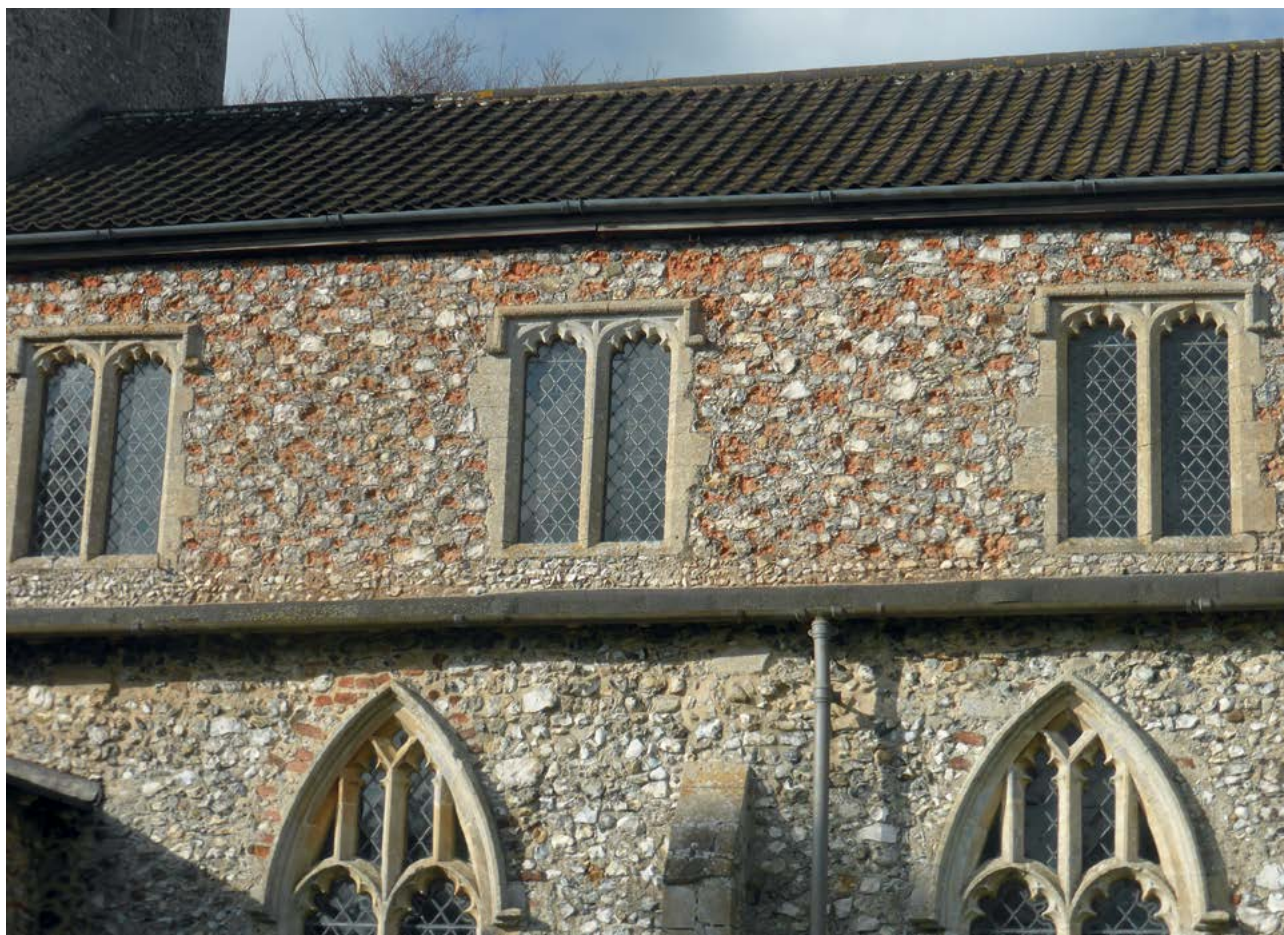
1.4. Little Massingham with Red Chalk used decoratively with knapped flints in the south clerestory.

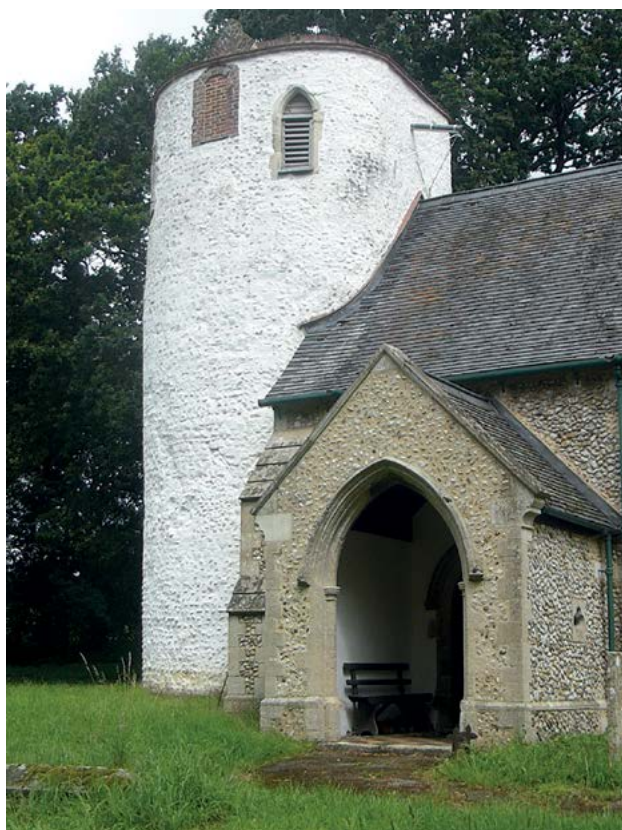
1.5. West Lexham tower after restoration with the chalk protected by multiple layers of lime water.

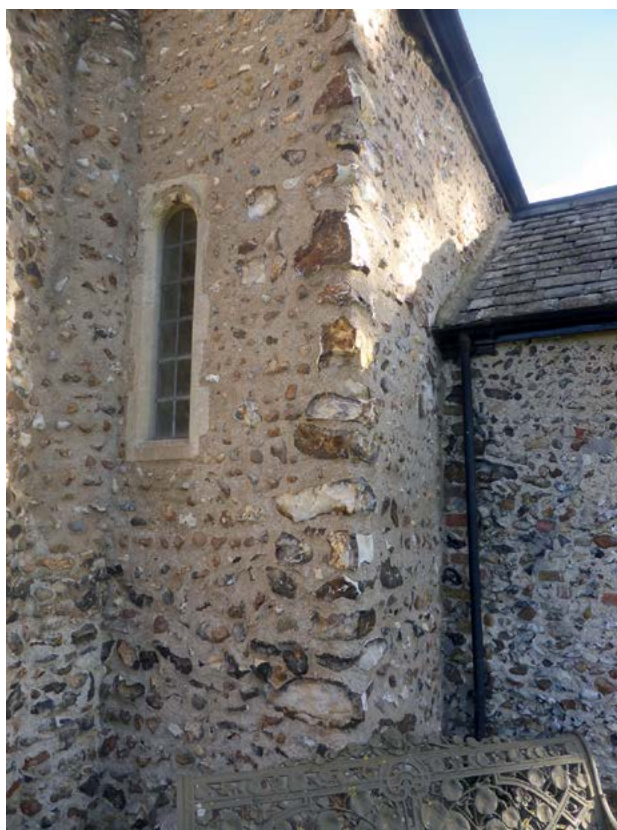
1.6. Framingham Earl nave south-west corner formed with large squared flints.

Flints were universal as an early building material. Framingham Earl (Fig. 1.6) is a conspicuous example of an early church, without any conglomerate or tiles where the quoins at the nave corners are all large flints. Surlingham church is another one which has mainly large squared flint nodule quoins except for one block of conglomerate in the south-west nave corner (Fig. 1.7). Others with just ordinary flint quoins, such as Themelthorpe, sometimes

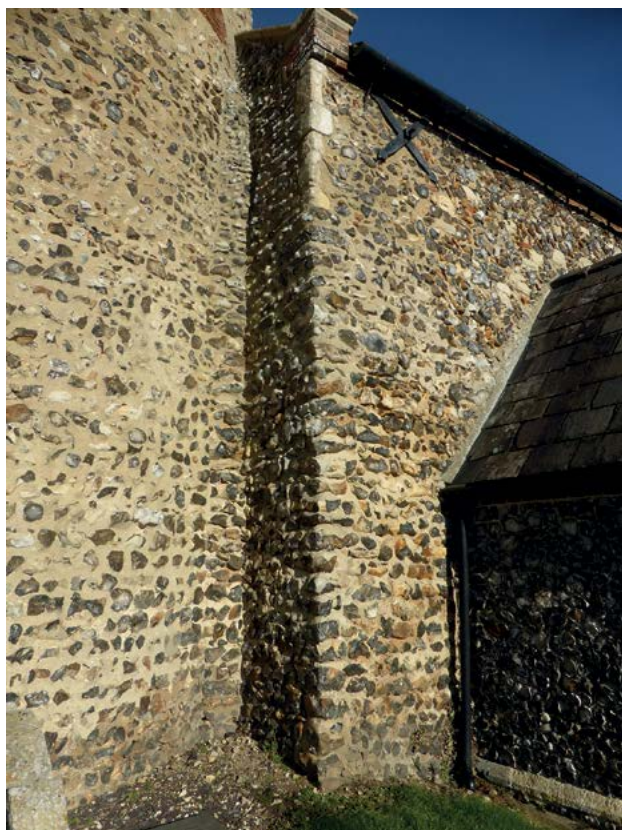
1.7. Surlingham nave south-west corner with squared flints, one piece of conglomerate and limestone near the top.

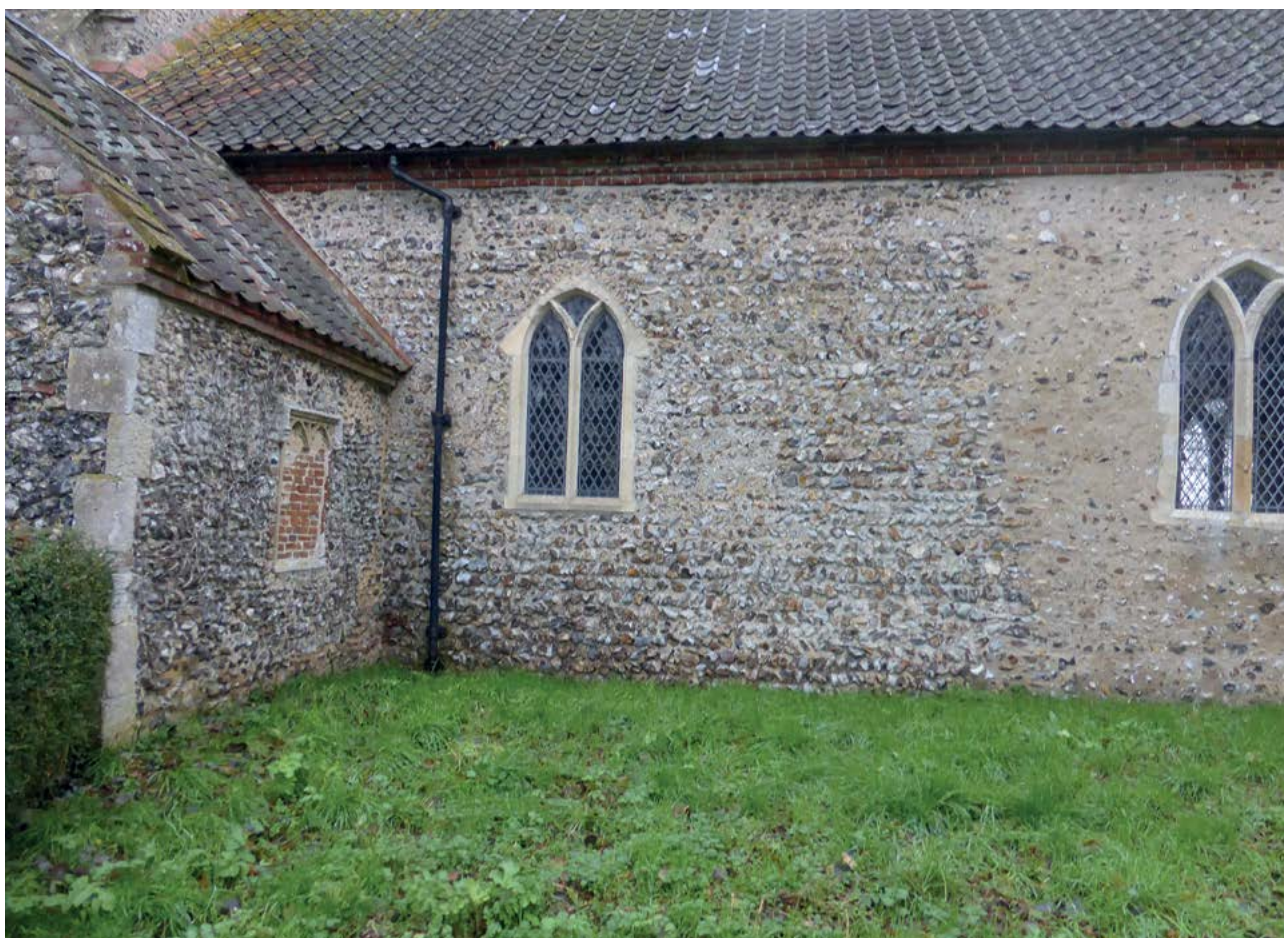
1.8. Themelthorpe nave south wall with areas of herringbone flintwork.

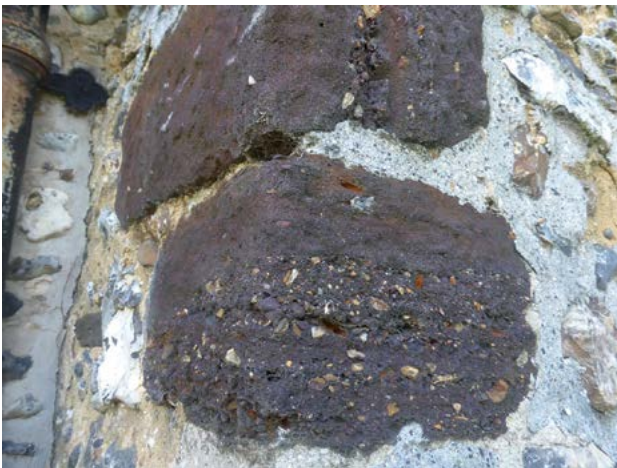
1.9. Ketteringham nave north-west corner with sandy and gravelly versions of conglomerate in the same quoins.

possible to find both sand and gravel in the same stone, as at Ketteringham (Fig. 1.9). Good examples of the gravelly conglomerate can be easily seen in the wall faces of the North Elmham ruin (Fig. 1.10). Fossil molluscs can on occasion be found alongside flints in the conglomerate as at South Wootton (Fig. 1.11). The presence of flint is a clear indication that a deposit is post-Cretaceous and therefore not of bedrock origin.

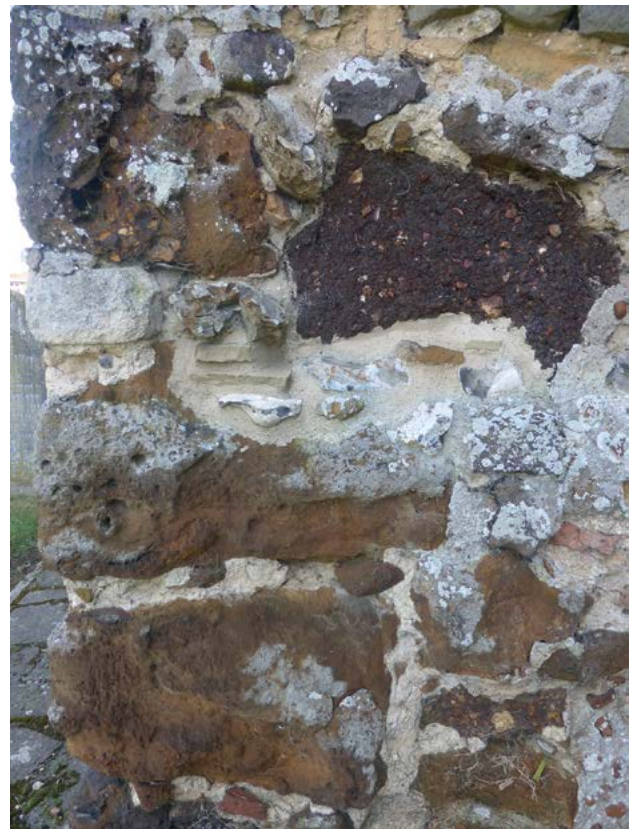
1.11. South Wootton nave north-west corner with conglomerate quoins with a mixture of light brown Carstone and a piece of darker conglomerate containing some fossil molluscs.

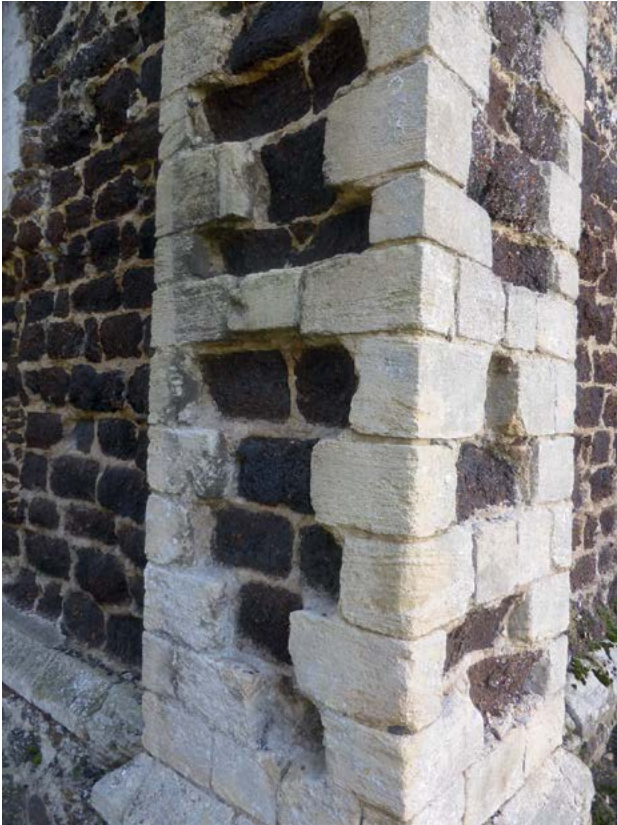
1.12. Ryston tower south-west buttress with limestone ashlar and heavily eroded conglomerate.

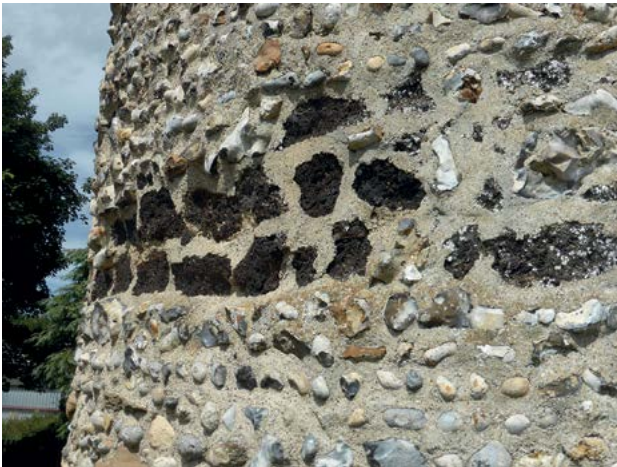
1.13. Mauthby round tower with layers of eroded conglomerate.

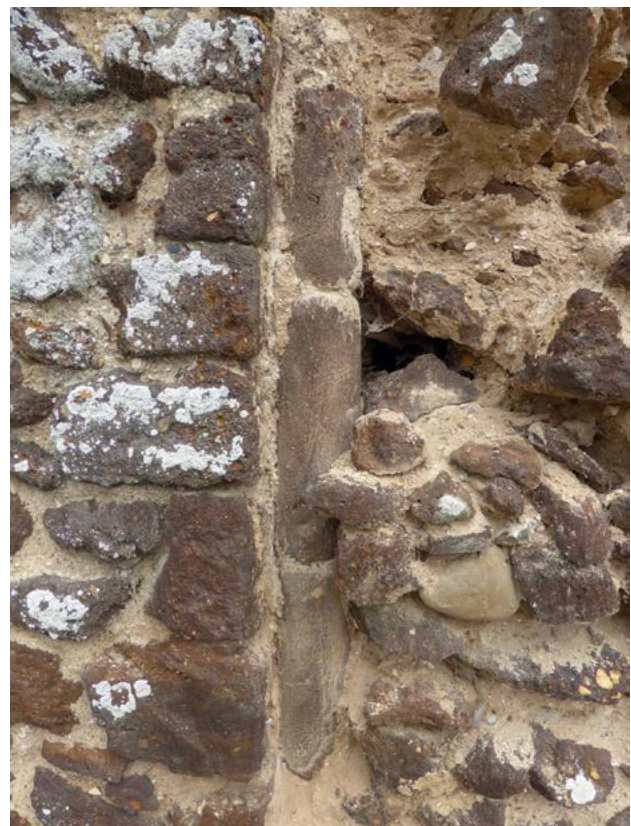
1.15. Burgh Parva nave blocked south doorway with conglomerate jambs and nook shaft.

In the fabric of eleventh- or early twelfth-century churches there is a good chance of finding conglomerate in quoins at the corners, and less frequently in windows and doorways where it has usually been replaced. High quality examples of finely shaped sandy quoins and voussoirs were used exceptionally in the tower arches at Great Ryburgh (Fig. 3.74), Yaxham (Fig. 3.201) and Little Snoring (Fig. 1.14), in a nook shaft of a blocked doorway at Burgh Parva (Fig. 1.15) and Bessingham (Fig. 3.19).

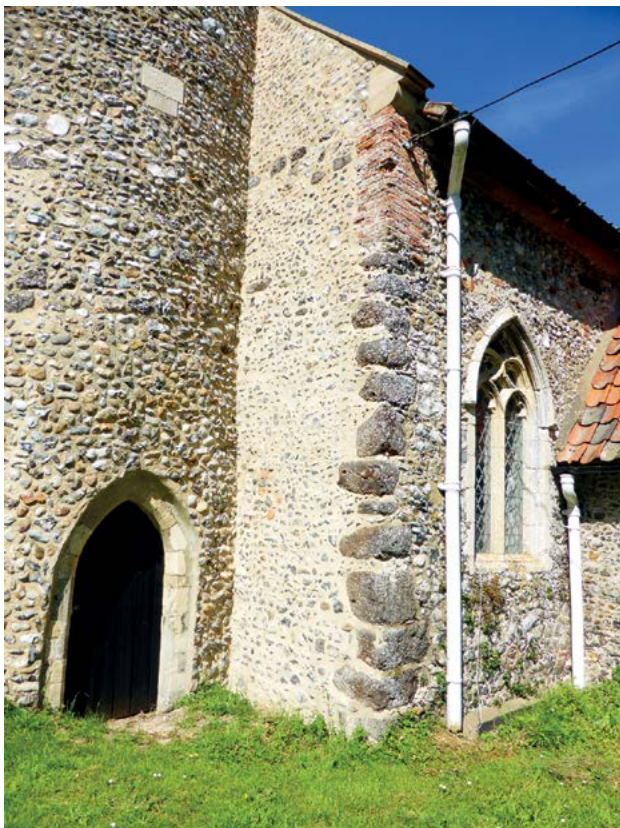
1.18. Sustead nave south-west corner with conglomerate quoins with additional tiles of uncertain date above.

Where to look for conglomerate in churches The first place to look for conglomerate blocks is in the west corners of the nave, as at Sustead (Fig. 1.18), and especially the

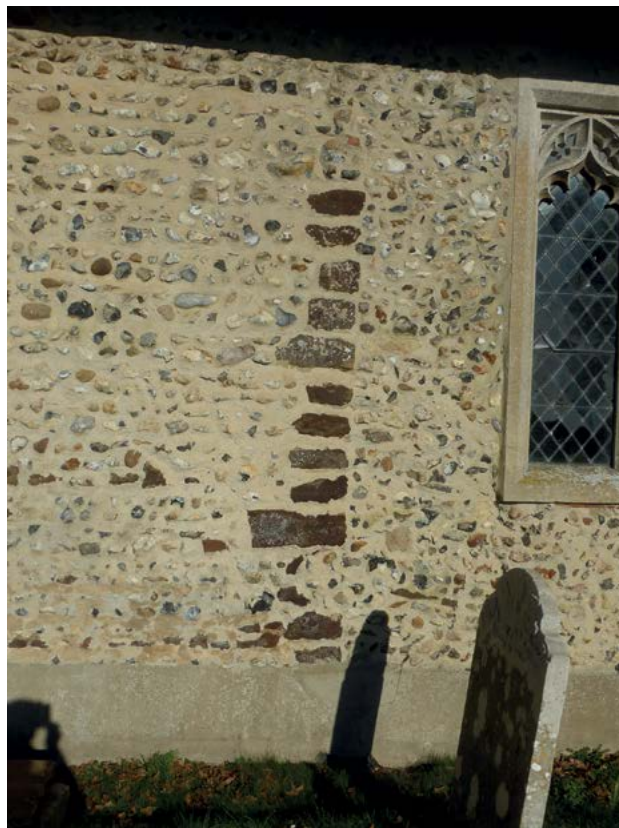
1.19. Ashby St Mary nave south-east corner showing as conglomerate quoins in the south wall where the nave and the present chancel south walls are aligned.

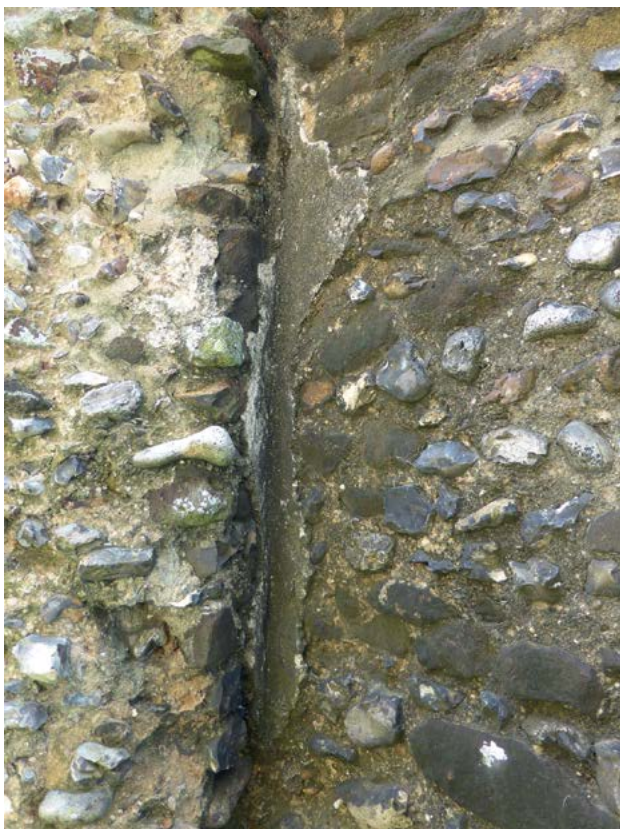
1.20. Little Snoring angle between the remaining west wall of the nave (to the left) and the tower with some surviving lime plaster.

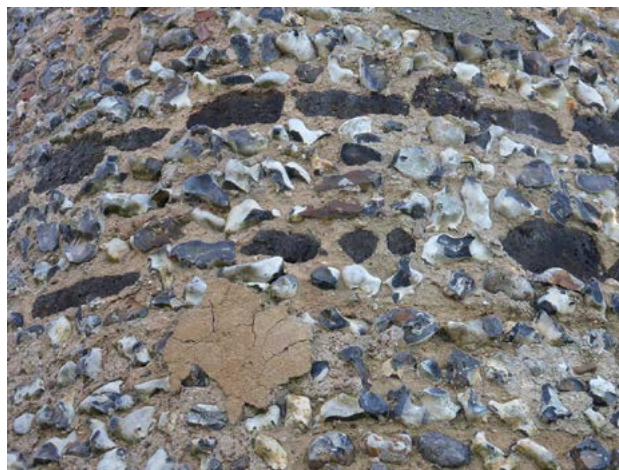
1.21. Bampton tower with a small area of lime plaster surviving *in situ*.

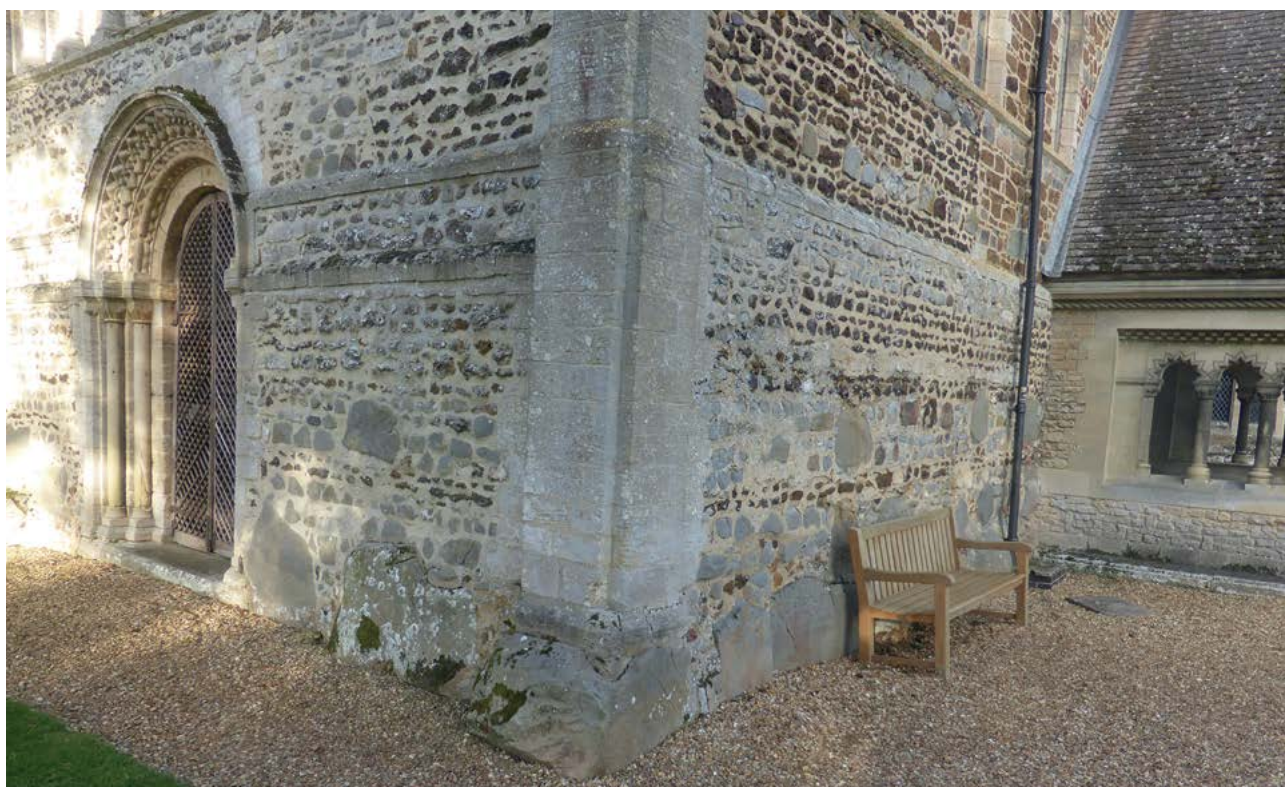
1.23. Castle Rising St Lawrence nave south-west corner with a foundation course of large blocks of grey quartzite.

Close by is St Lawrence's church in Castle Rising village built as a part of the planned town next to the Norman castle in c. 1140. Here the foundation course of the nave is made of massive blocks of grey quartzite up to 1.5m across which could not have been carted far from the quarry site (Fig. 1.23). That same stone was also used in smaller pieces to build the castle keep (Fig. 1.24). The central tower at Lawrence's has one window with Roman tiles (Fig. 1.25). So, the quartzite used in St Lawrence's church and in the ruined church under the castle earthworks seems to have had two origins, from a Roman quarry or building and from a contemporary quarry.

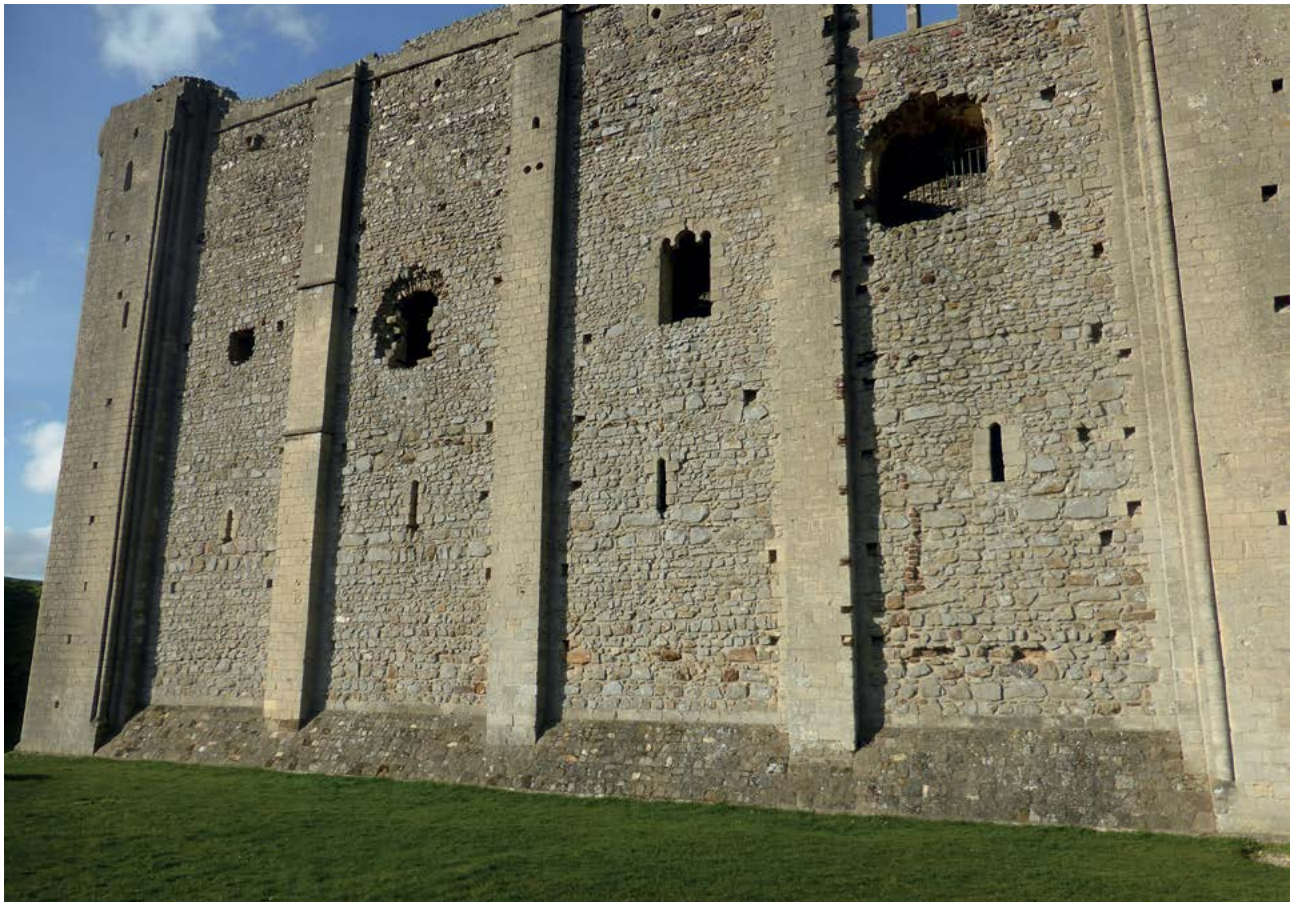
1.24. Castle Rising castle keep south side built with limestone ashlar buttresses separated by panels filled with blocks of grey quartzite of varying sizes.

Castle Rising St Lawrence's church (Fig. 1.22). It was also used extensively in the wall facing of Castle Rising Castle between the limestone ashlar buttresses (Fig. 1.24). So, Ling Common is likely to be at least one source for much of this material. Robin Stevenson said he had also found some of this stone in White Hills Pits, 3km to the east of the village (Tim Holt-Wilson *per comm.*), so there may have been more than one quarry in the area.

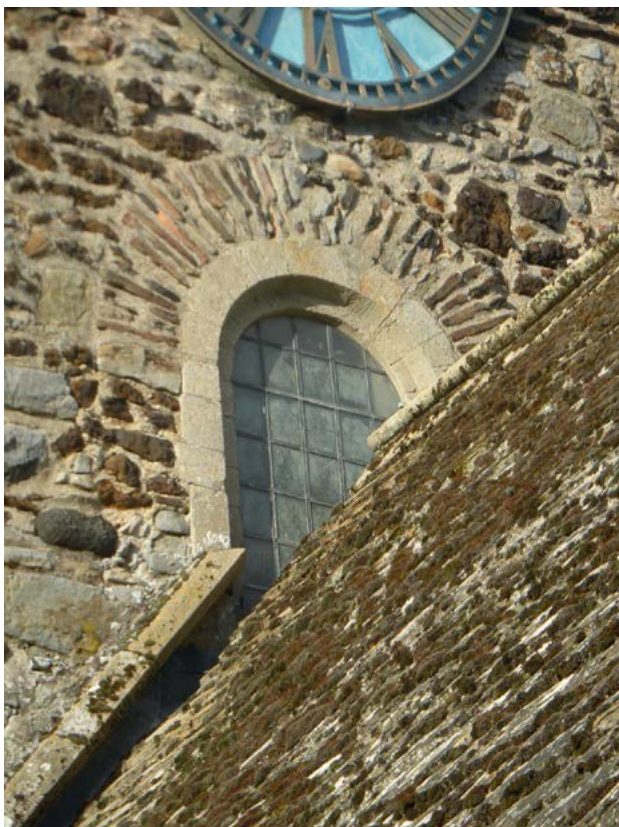
1.25. Castle Rising St Lawrence nave south wall Roman tiles over a window.

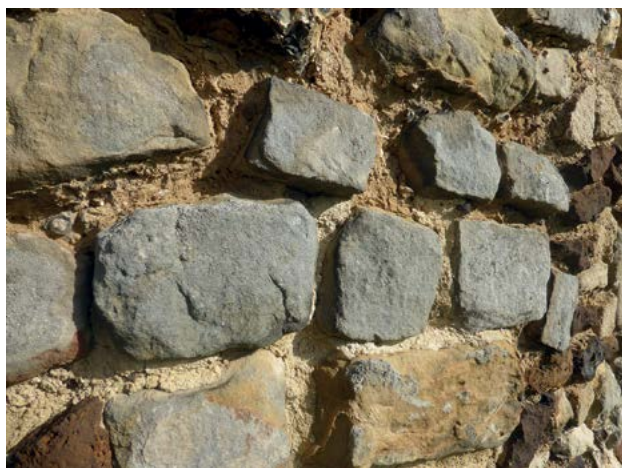
1.26. Appleton tower with grey quartzite blocks from Denbeck Roman villa nearby.

Grey quartzite blocks, some squared, are prominent in the walls of the ruined round tower at Appleton 4.5km to the north-east of Castle Rising (Fig. 1.26). Roman tiles were also used in the tower arch. The Appleton Roman villa at Denbeck Wood, 800m to the east, was excavated by Rainbird Clarke in 1947-8 (Gregory, 1982), but he did not publish his results. The only description of the villa published at the time was a very short note in the *Journal of Roman Studies* for 1948 under 'Roman Britain in 1947'. This described the villa as built of a 'local sandstone' with flints and tiles supporting a timber superstructure (Showers 1948, 98-9). Luckily, there are photographs of the excavation taken by the professional photographer Hallam Ashley which are held in the NHER (Fig. 1.27). These show that the excavation was not of a high standard, and the walls were not cleaned and therefore not well

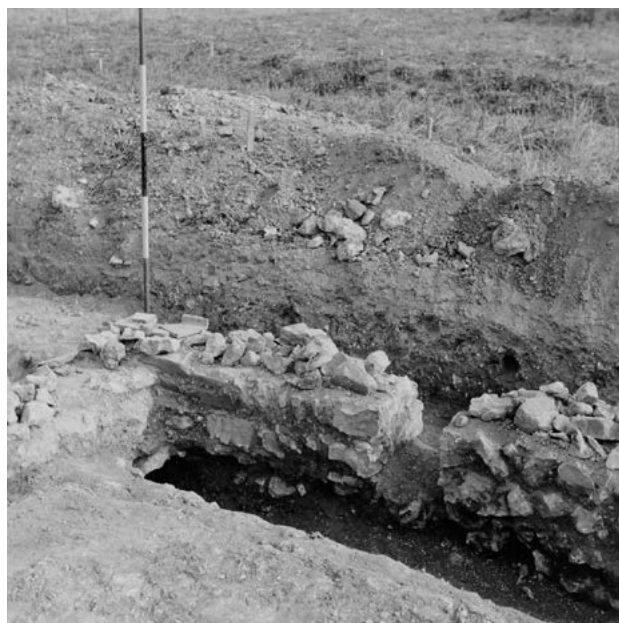
1.27. Denbeck Roman villa 1948 excavation with walls believed to be built of blocks of grey quartzite, and a tegula rests on a wall foundation. Photo by Hallam Ashley.

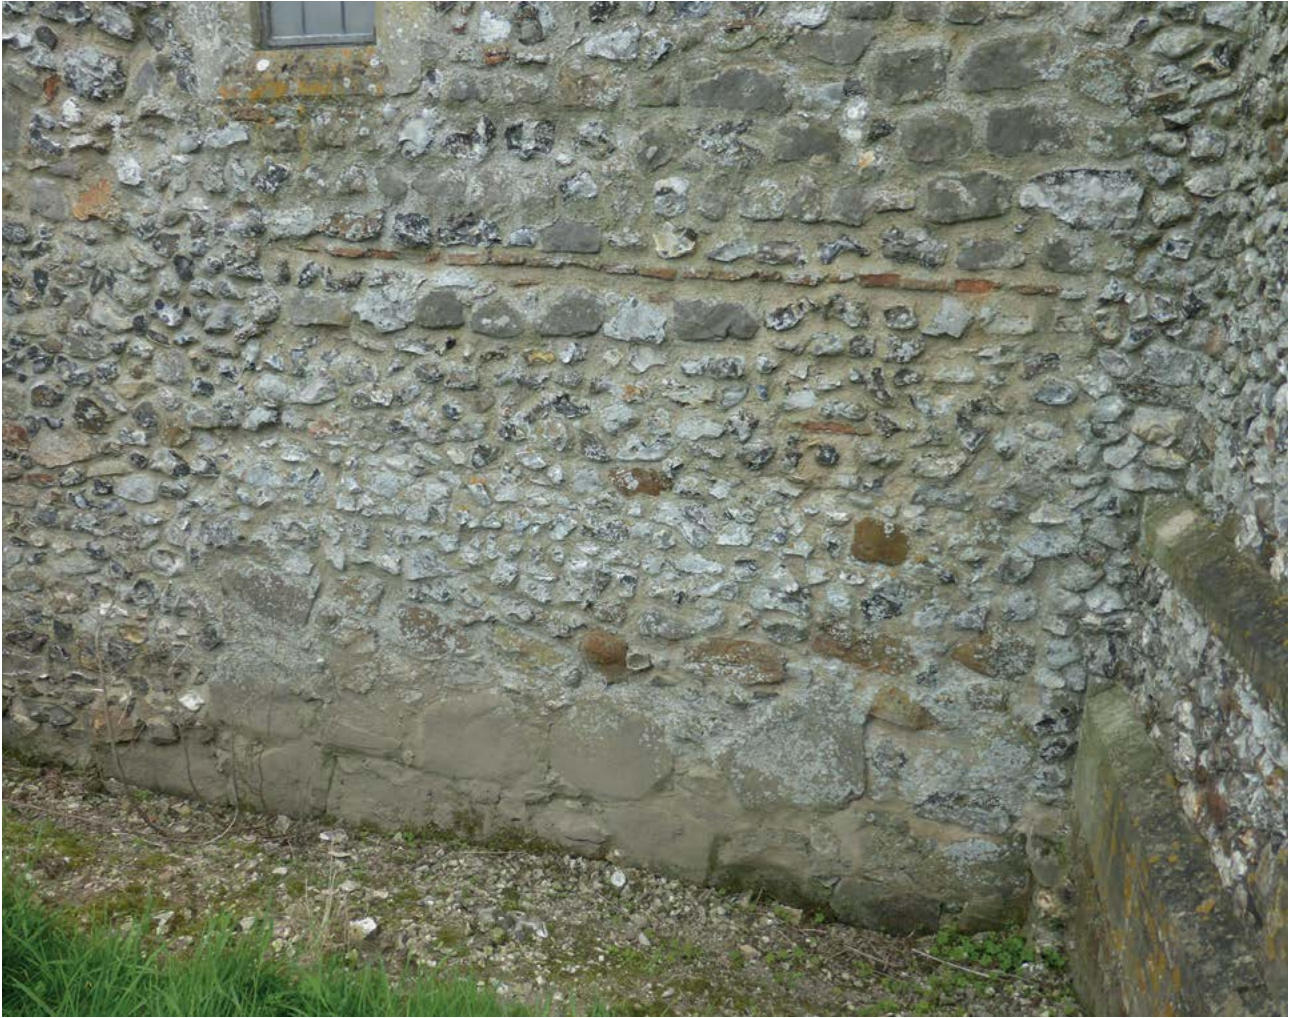
1.28. Flitcham tower north wall with blocks of grey quartzite, flints and a course of Roman tiles.

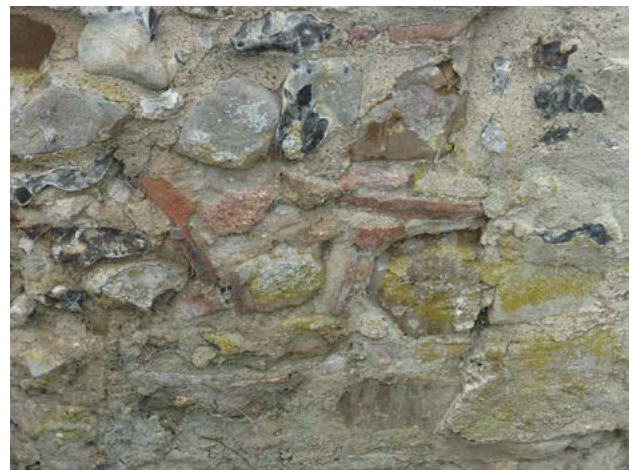
1.29. Flitcham tower east side with Roman tiles and *opus signinum*.

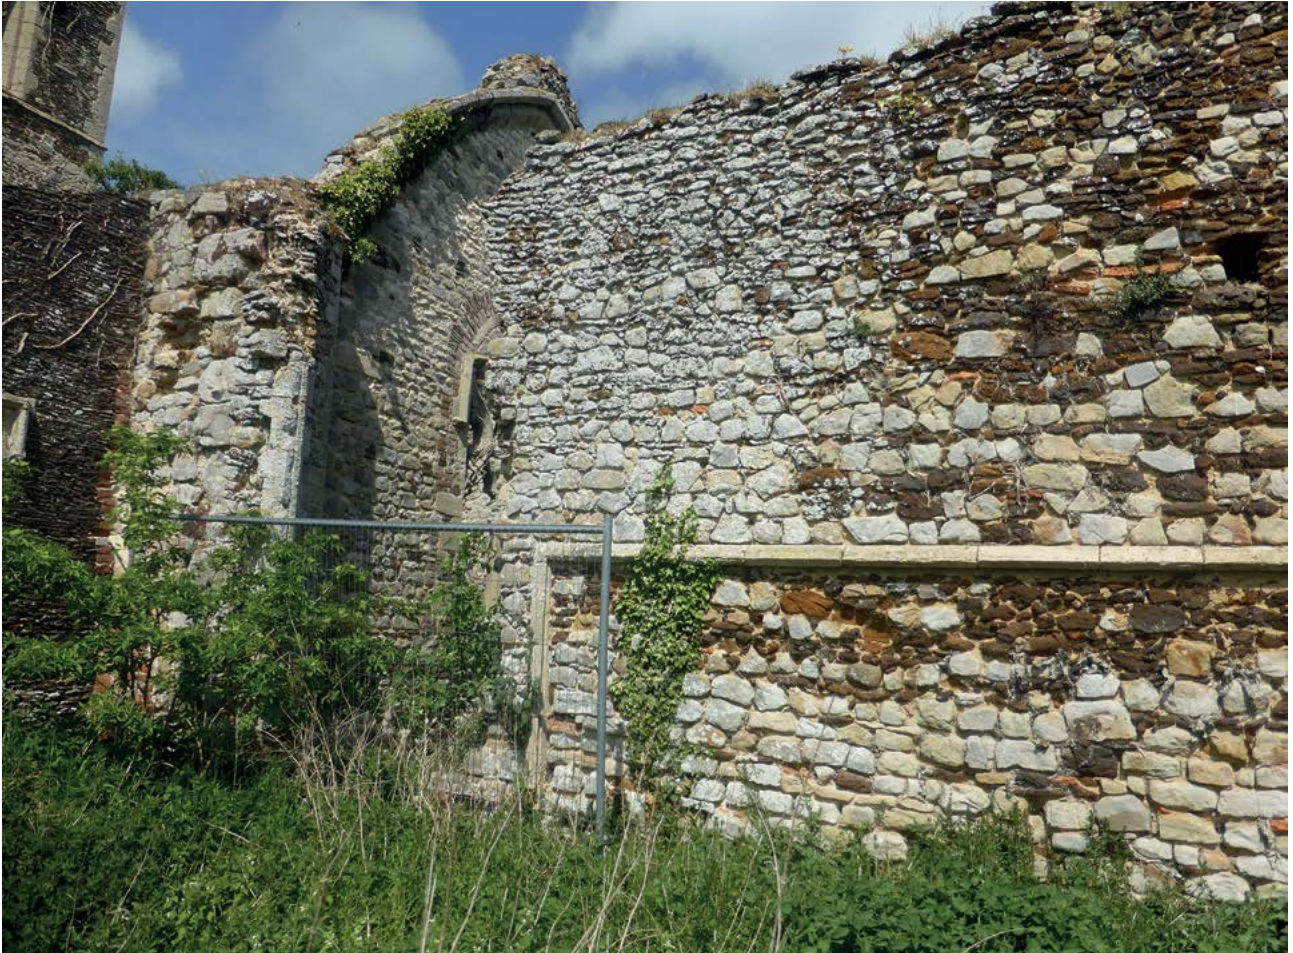
1.31. Babingley north wall interior of chancel with squared blocks of grey quartzite.

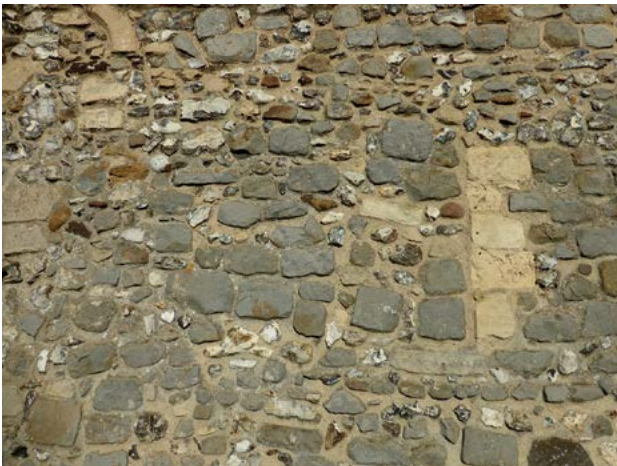
1.32. Brancaster chancel south wall with squared blocks of grey quartzite.

Blocks from the fort have been found reused in three churches close to Brancaster along the north coast. The best places to see them is in the south wall of the chancel at Brancaster (Fig. 1.32) and in the round tower at Burnham

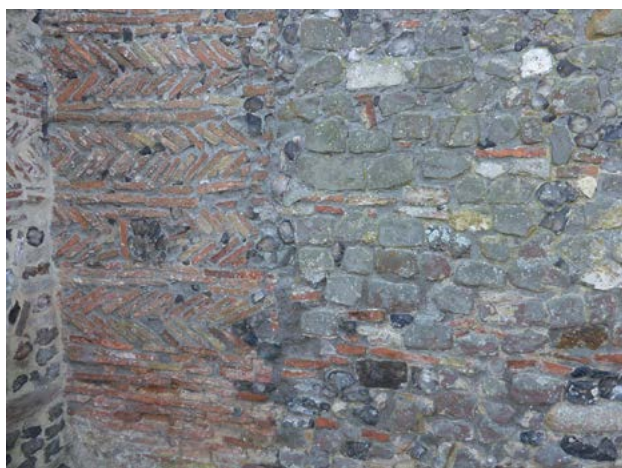
1.33. Reedham nave north wall with Roman tiles laid herringbone and grey quartzite.

The largest quantity of grey quartzite is in Reedham church, along with a very impressive quantity of Roman tiles, some laid in a remarkable herringbone fashion not seen elsewhere to this extent in Norfolk (Fig. 1.33). Reedham is followed in quantity by Halvergate (Fig. 3.83) and Limpenhoe churches (Fig. 1.34) where it is also

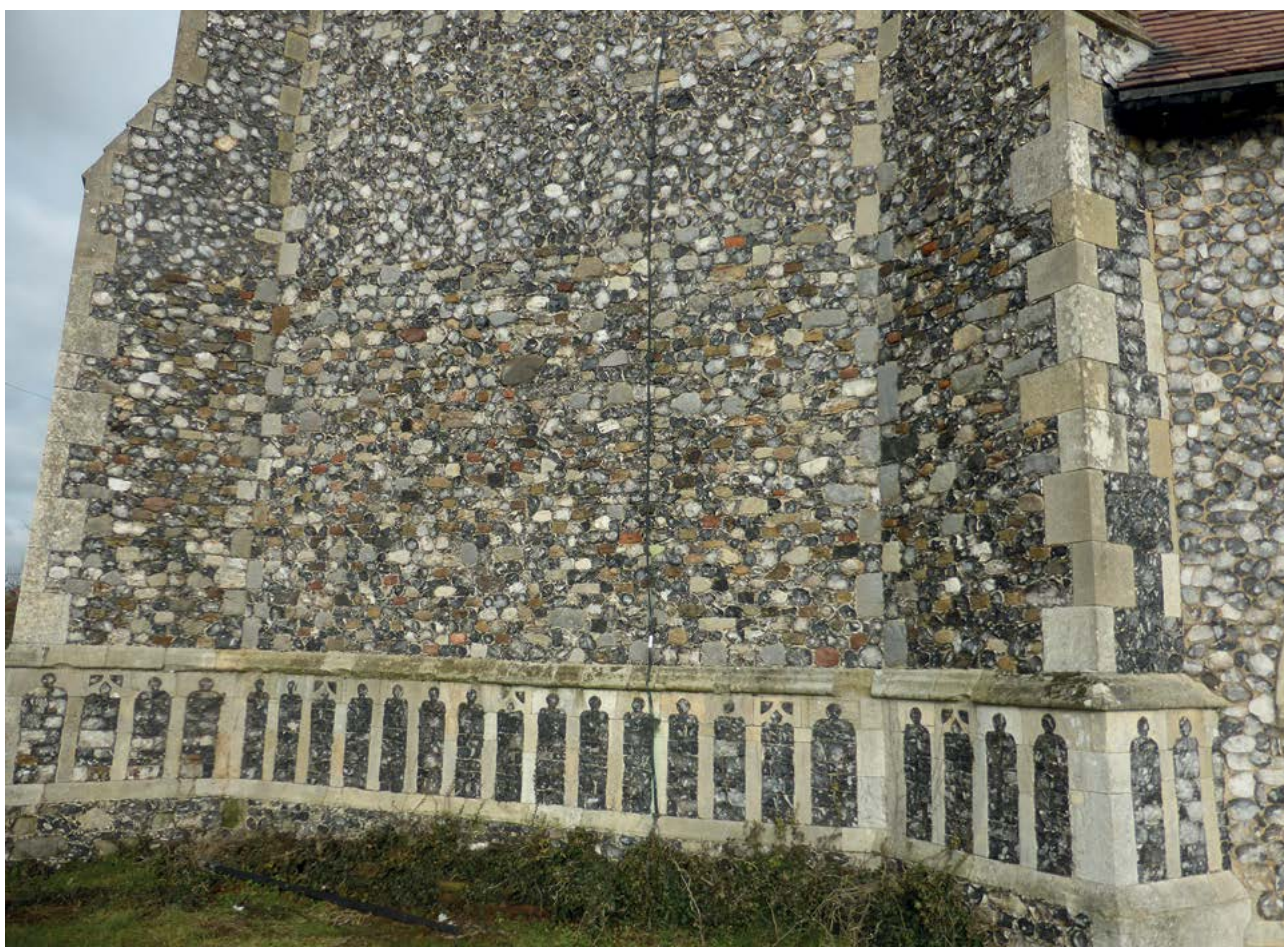
1.34. Limpenhoe tower south side with blocks of grey quartzite.

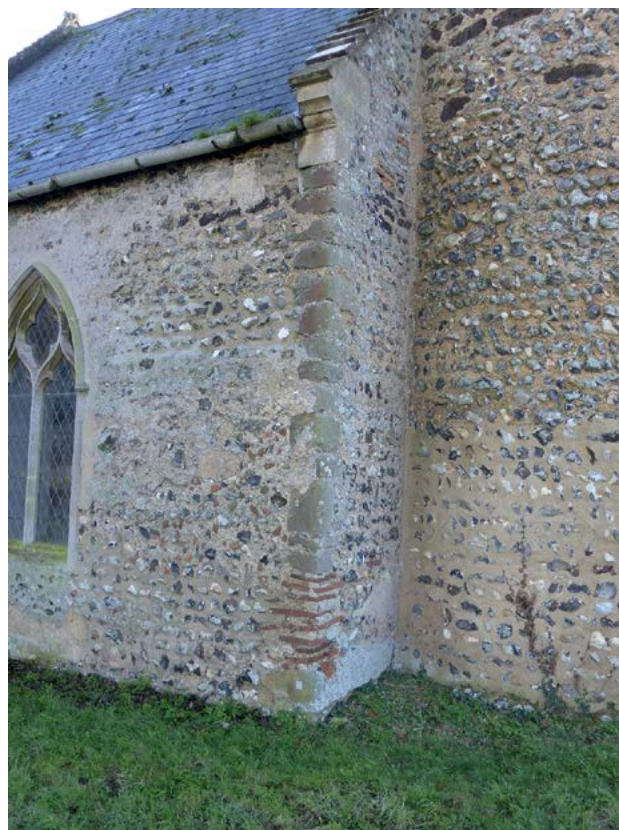
1.35. Brampton nave north-west corner with Roman tiles and grey sandstone quoins identified as a Millstone Grit.

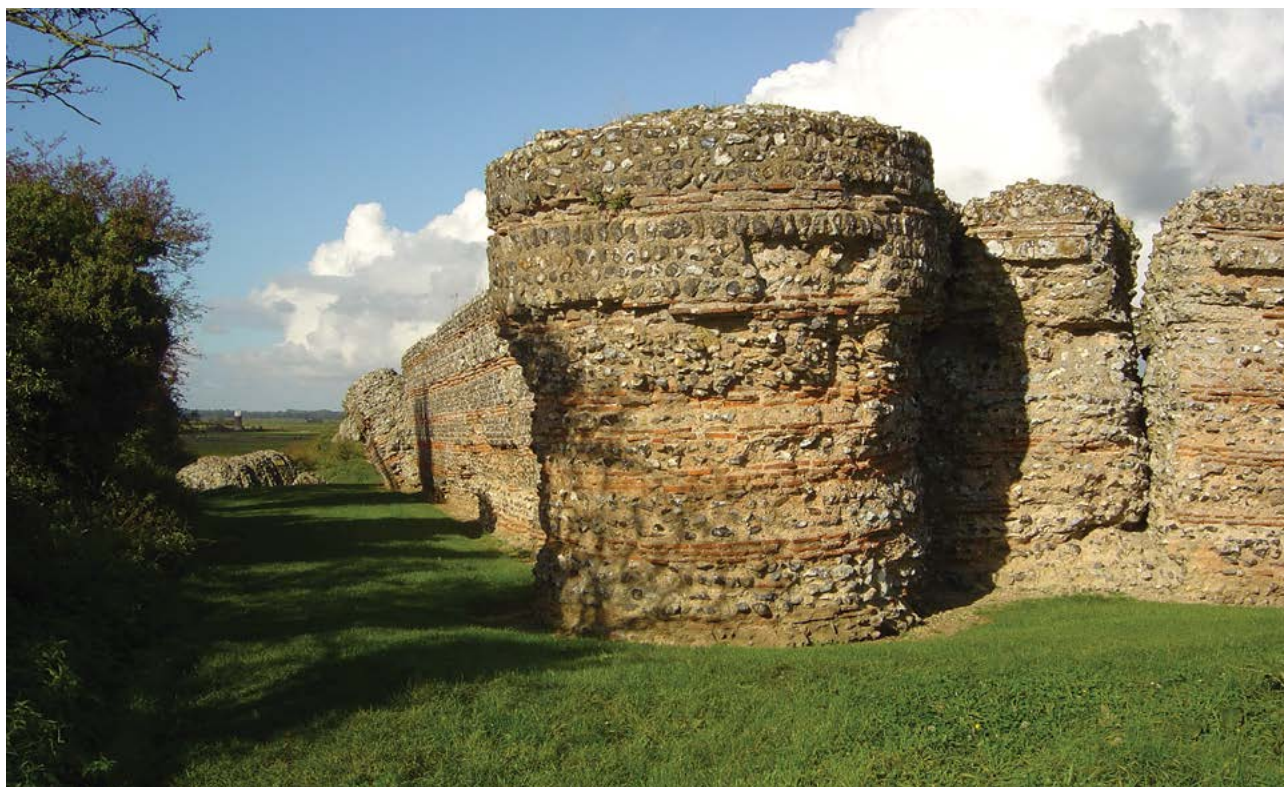
1.36. Burgh Castle Roman fort south-east bastion with layers of wall bonding tiles.

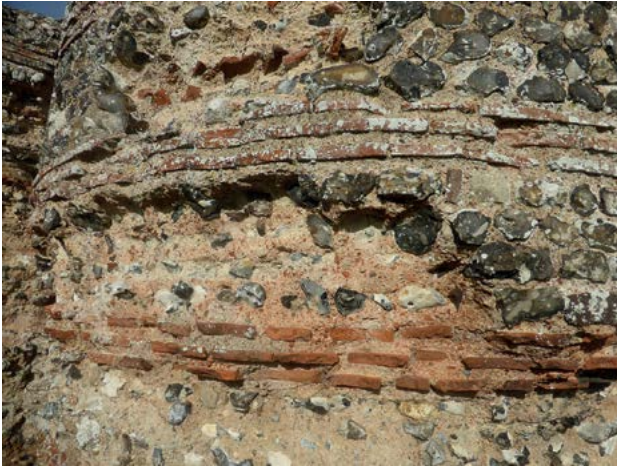
1.37. Burgh Castle Roman fort an eastern bastion with both wall bonding tiles and *opus signinum*.

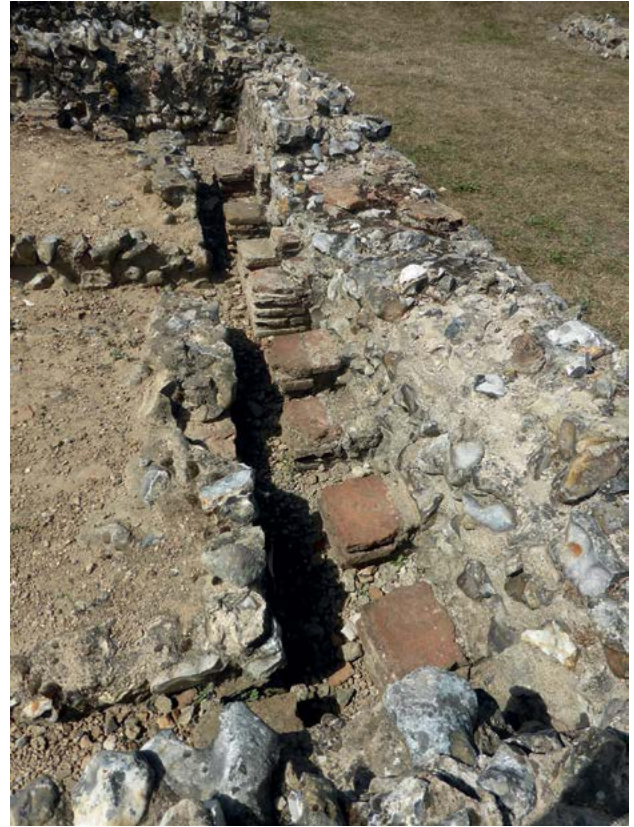
1.38. Caister-on-Sea Roman fort internal building with piles of tiles for the hypocaust heating system.

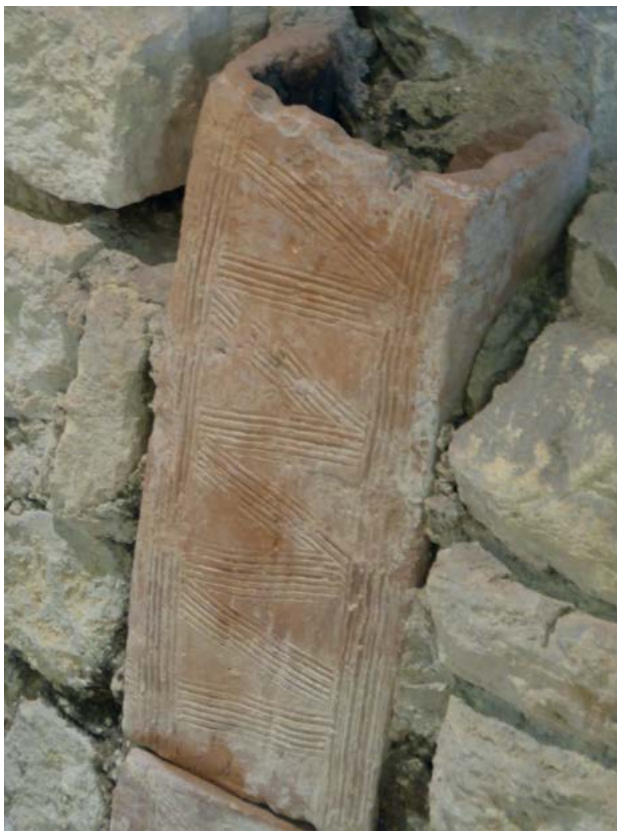
1.41. An example of a Roman flue tile in Chedworth Roman villa, Gloucestershire: not easy to recognise in churches because the scratched surface would not be exposed, although a few examples were found in the North Elmham tile collection.

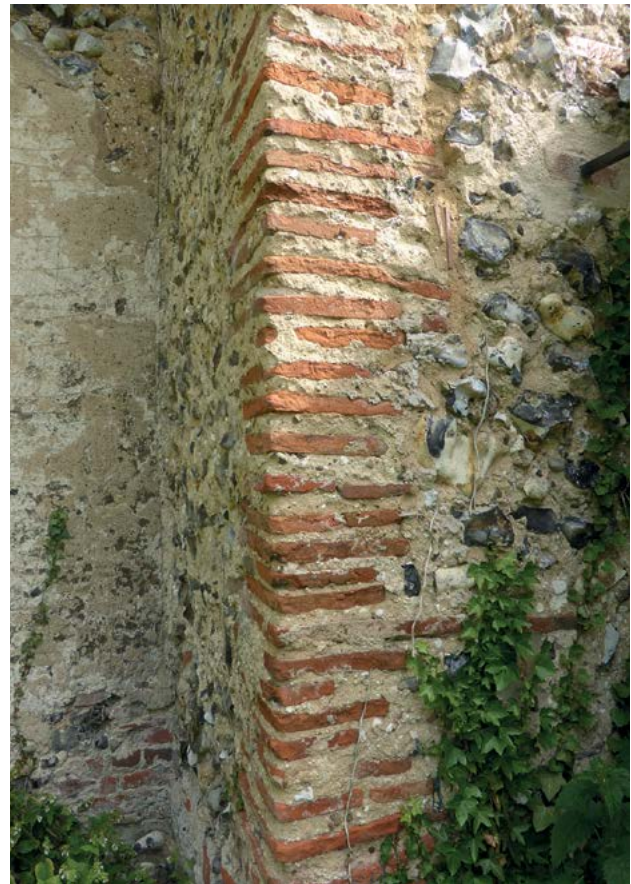
1.42. Oxnead nave south-west corner built entirely of Roman tiles

The church where Roman tiles can be seen best as quoins at nave corners is at Oxnead (Fig. 1.42), close to the Roman
