Introduction

Project aims

The aim of this project is to assess the distribution and use of iron-bound or ferruginous gravels and sands, Roman tiles and (Leziate) grey quartzite stone in Norfolk's early churches. The author has approached this as a field archaeologist rather than as an architectural historian and he hopes that this will add some new perspectives to a fascinating subject.

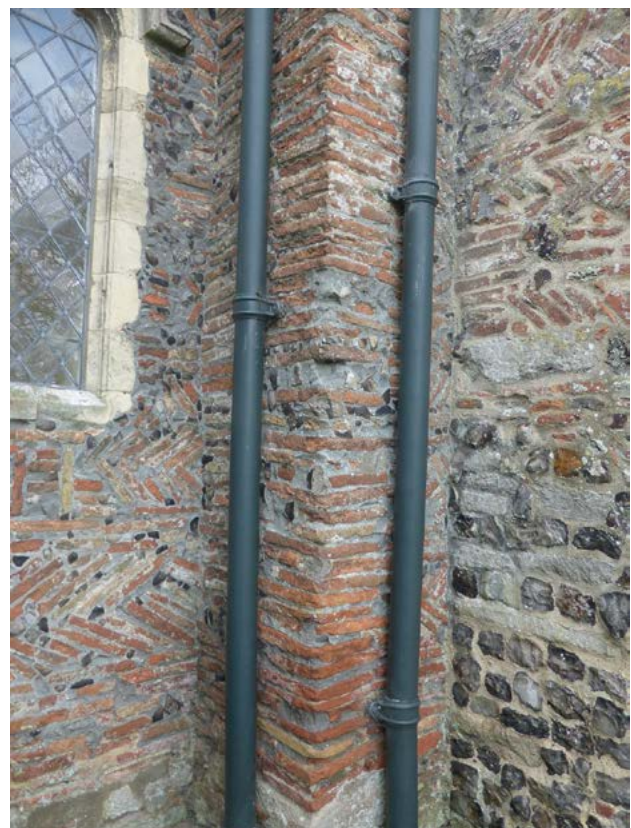
1.43. Reedham nave north-east corner also built entirely of Roman tiles.

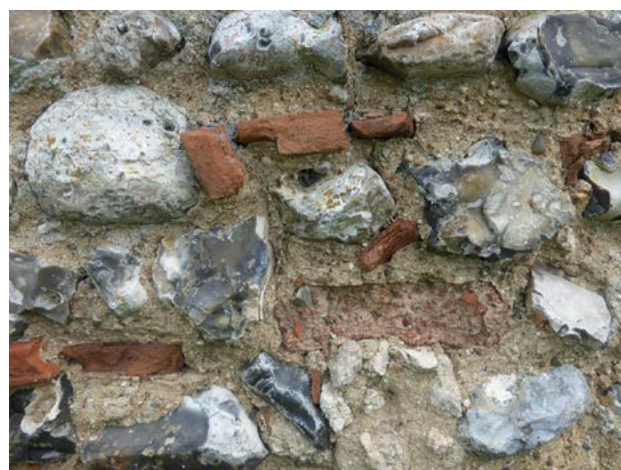
1.47. Haveringland round tower with Roman tiles and a blocks of *opus signinum*.

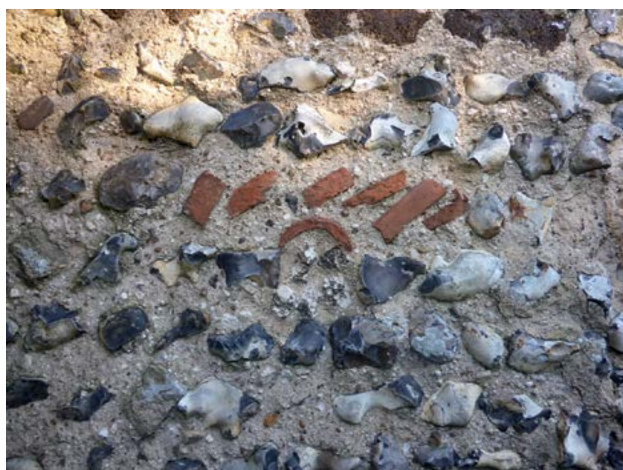
1.46. Brampton nave west wall Roman tiles including a rare example of an *imbrex*.

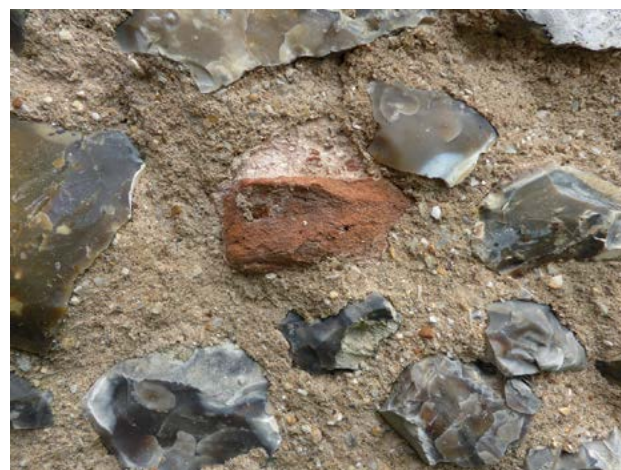
1.48. Sparham south aisle Roman tiles with *opus signinum* stuck to it.

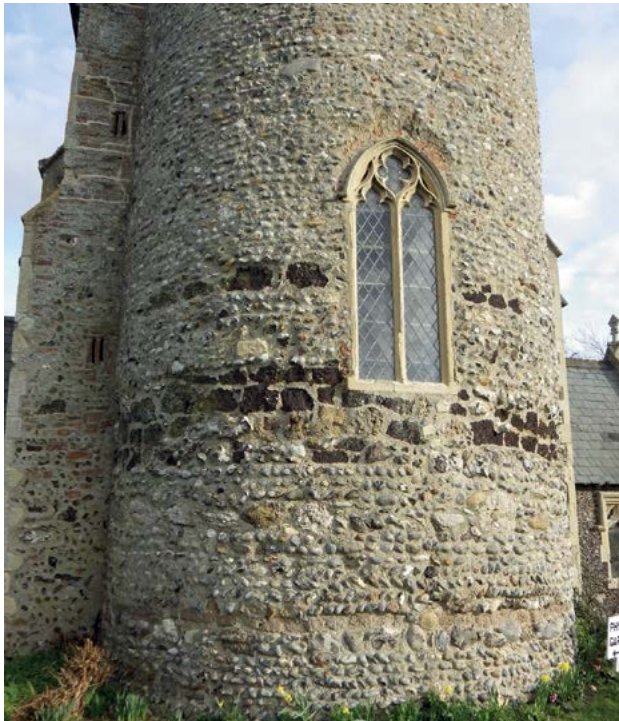
1.50. Mautby round tower with unidentified blocks of a white material near the base of the tower (Photo by Tim-Holt-Wilson).

There is a single course of buff-coloured stones near the bottom of Mautby church tower of a type which have not yet been identified (Figs 1.50-1). This certainly deserves further research.

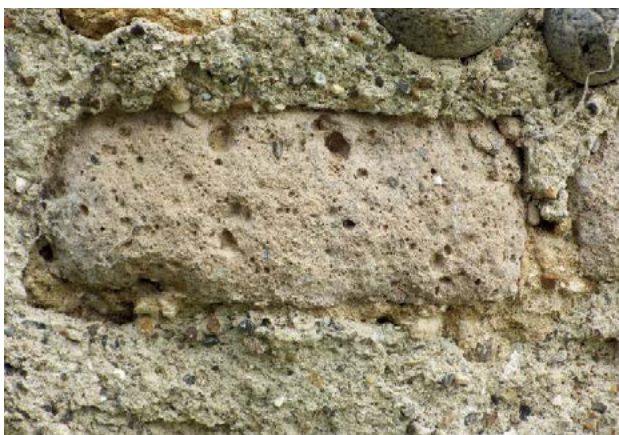
1.51. Mautby round tower a close-up view of one of the blocks of white material in Fig. 1.50 (Photo by Tim-Holt-Wilson).

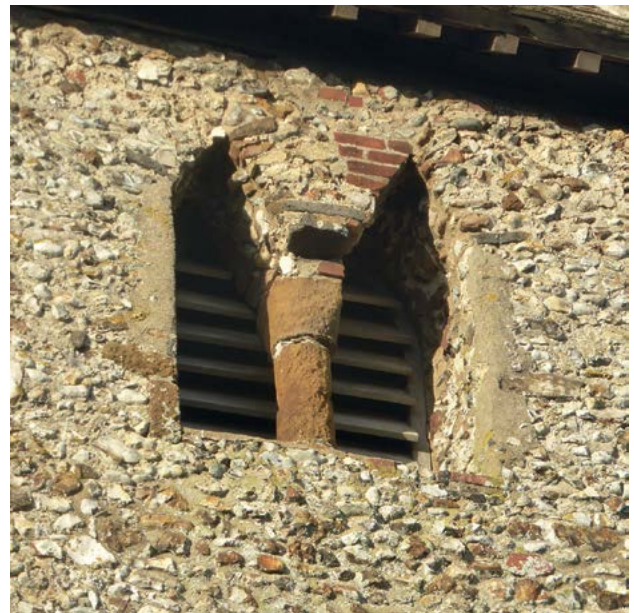
1.52. Newton by Castle Acre tower belfry window with a possible Carstone mid-wall shaft and capital. This triangular window head was rebuilt in the 1929 restoration with a mixture of conglomerate, Carstone, brick, flints and pieces of lava quernstone.
